UAS PROGRAM

Concept of Operations

Engineering Supplemental Structure Assessments

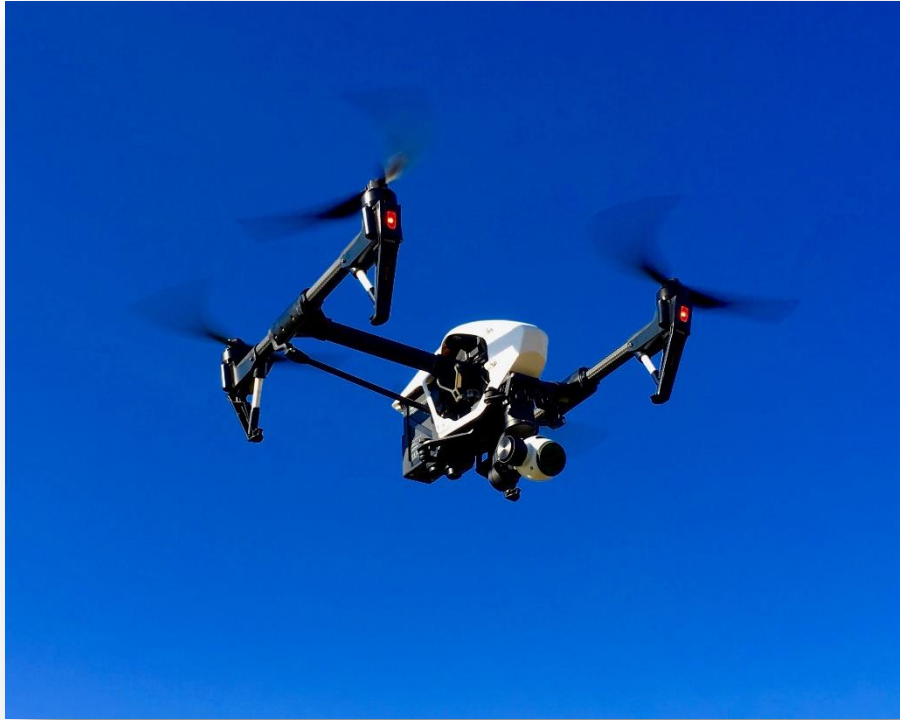
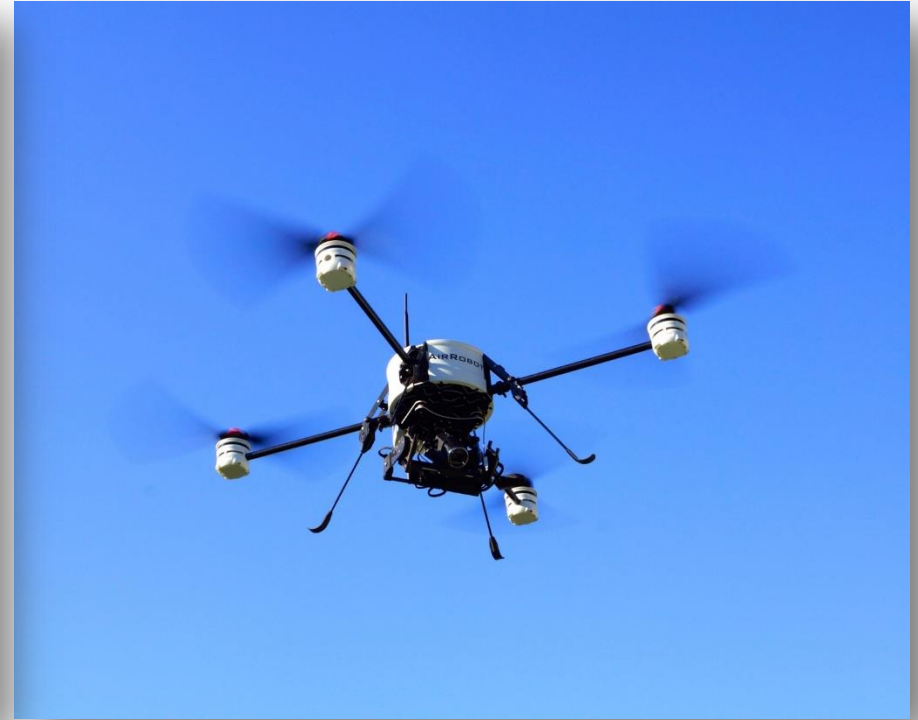
Example Of Line of Sight Aircraft

- **15-35 minutes of flight time**
 - Line of sight, operations from mobile platforms
 - HD video, high resolution photo, thermal
 - Automated and manual missions

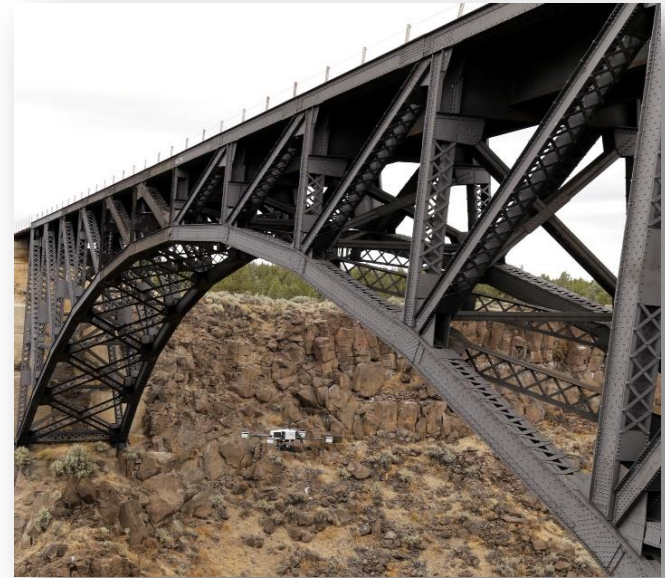
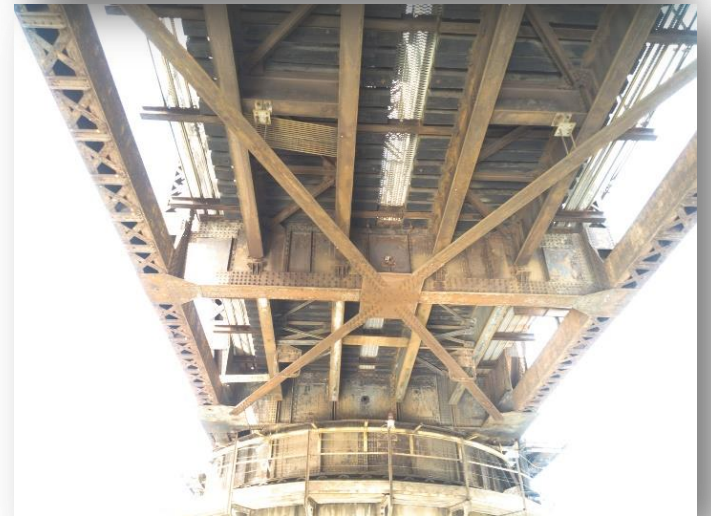
Engineering Supplemental Structure Assessments

- Capability developed to visually inspect large structures
- Easy access to all areas of bridge structure
- Wide range of product outputs including video, still images, 3D models, and change detection
- Developed automated change detection for elevation and alignment

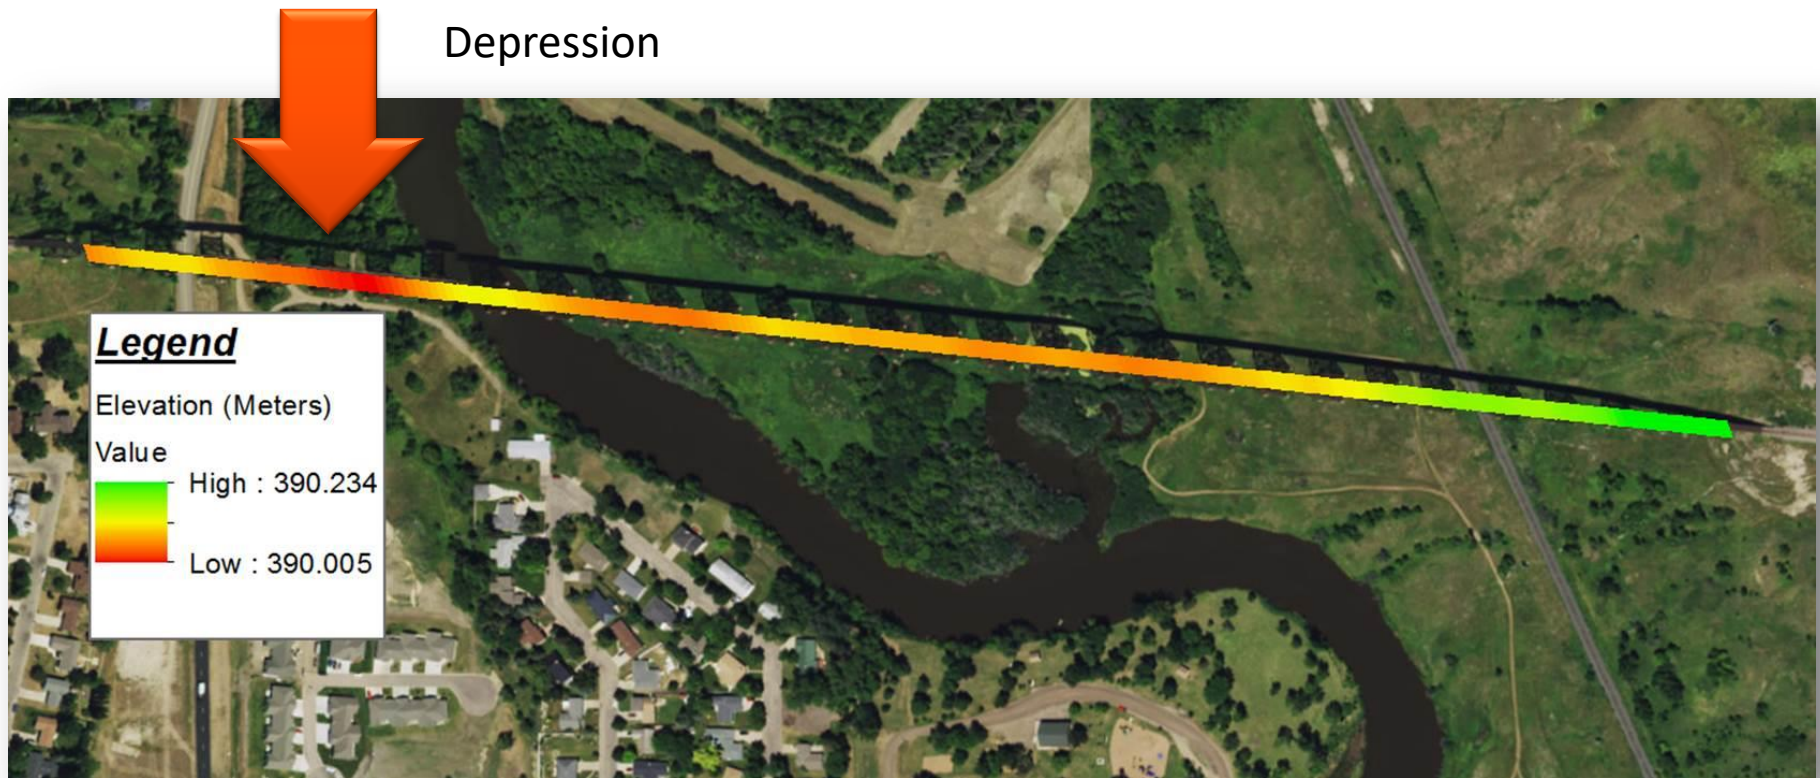
Lidar Bridge Deck Elevation Profile

- Simple one page graph showing the condition of bridge profile
- Results that allows simple change detection
- Same type of results can be produced for bridge alignment

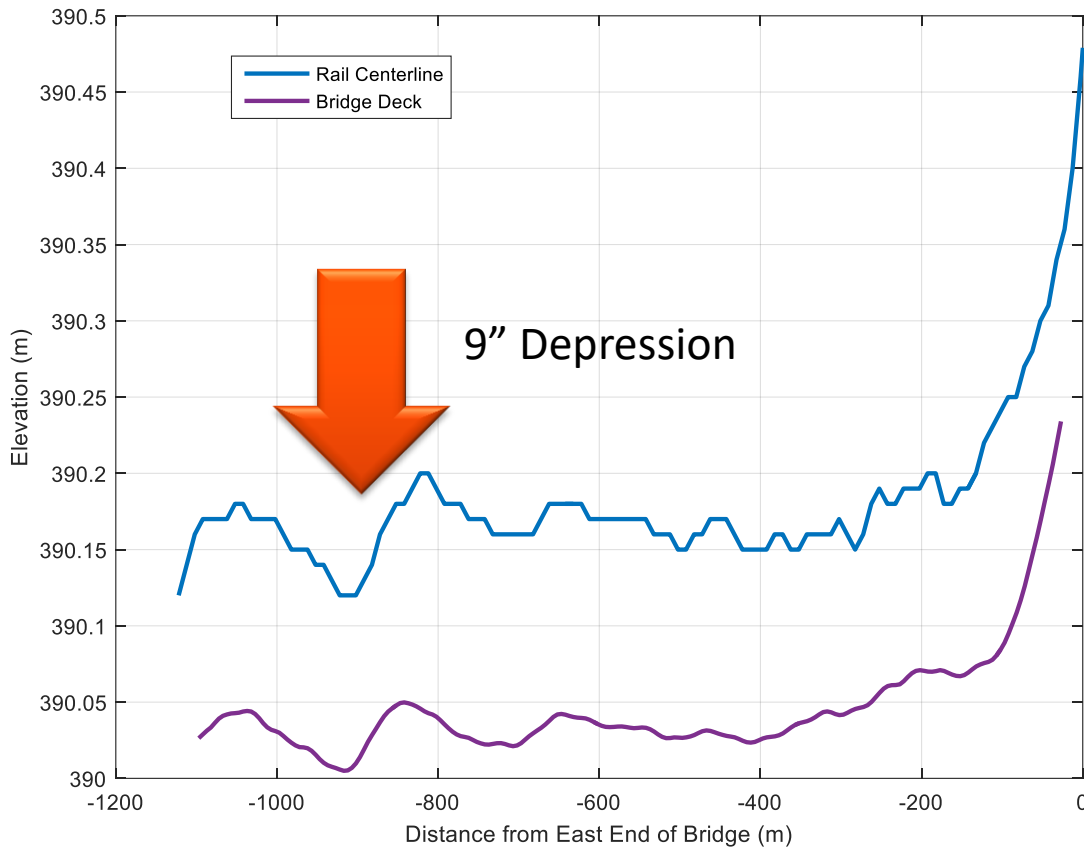
Bridge Elevation Profile

Determine the elevation profile through the track centerline calculated from lines created on the top of each rail utilizing the point cloud image.

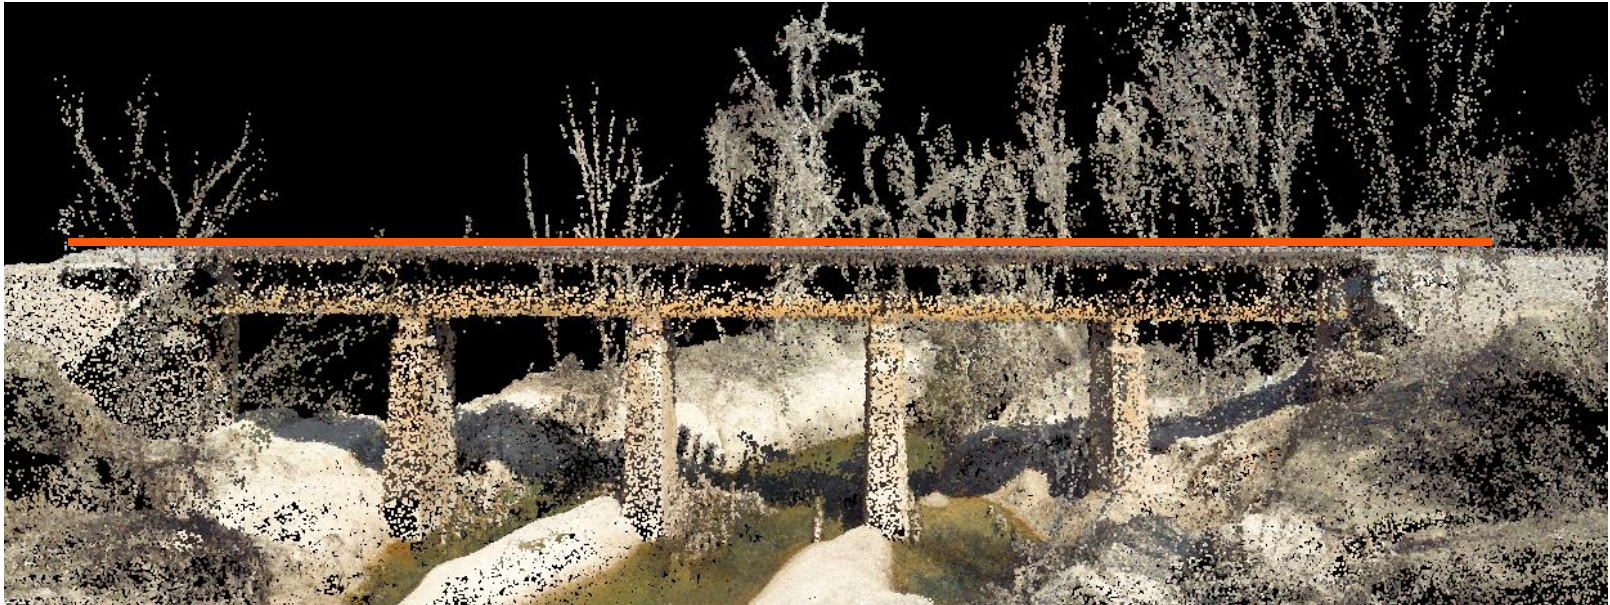
Bridge Alignment Profile

Determine the alignment profile of the track centerline determined from lines created on the top of each rail utilizing the orthomosaic image.

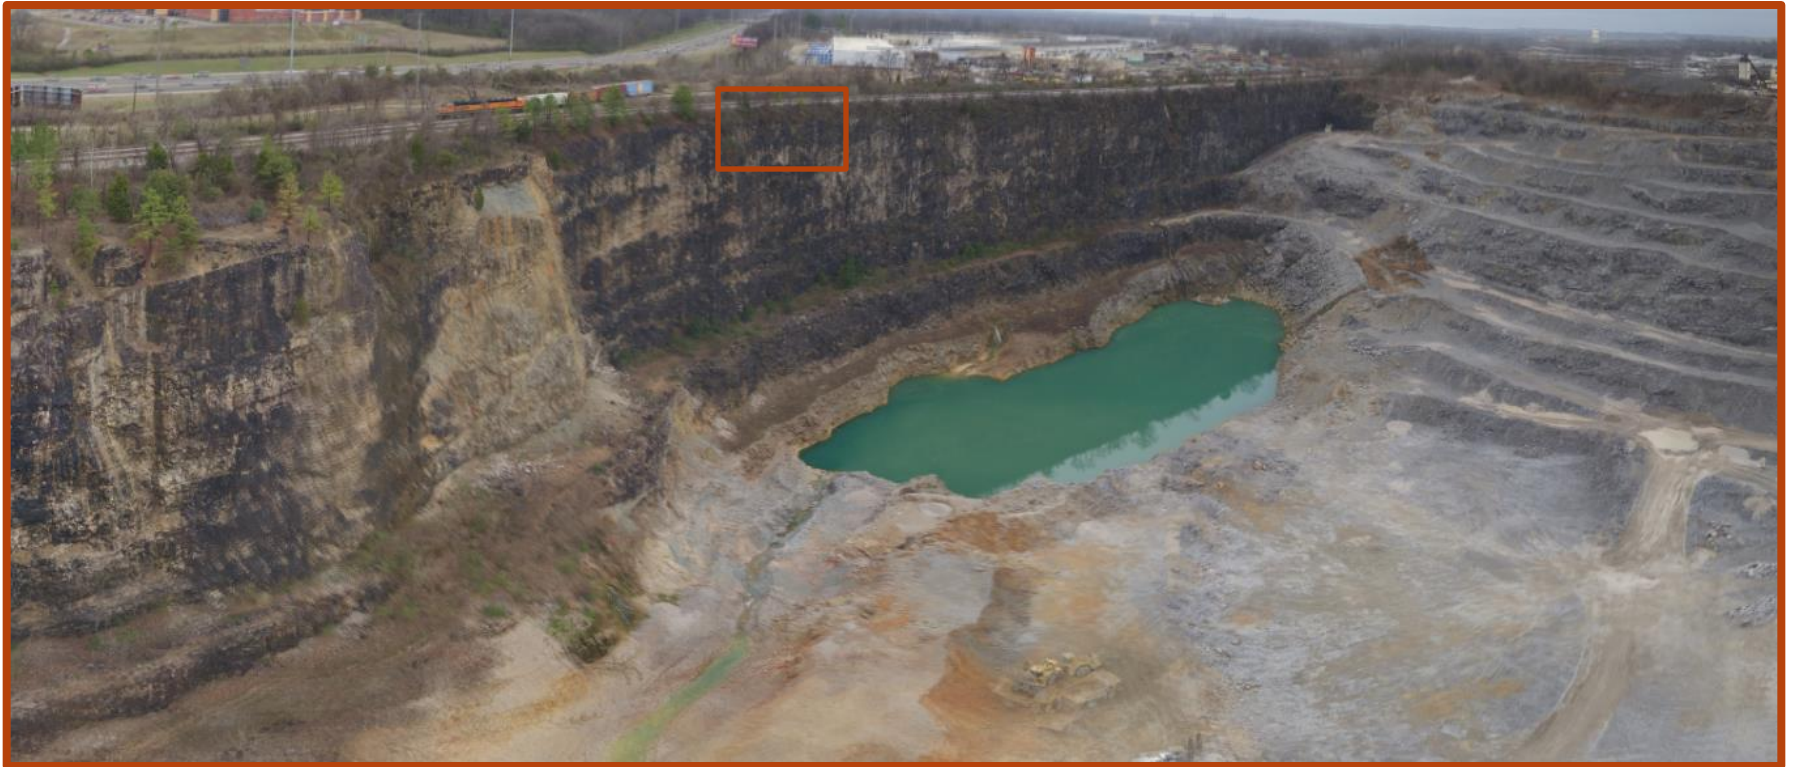
The stitching technique can be applied to areas of concern to expand detail of several images over single images

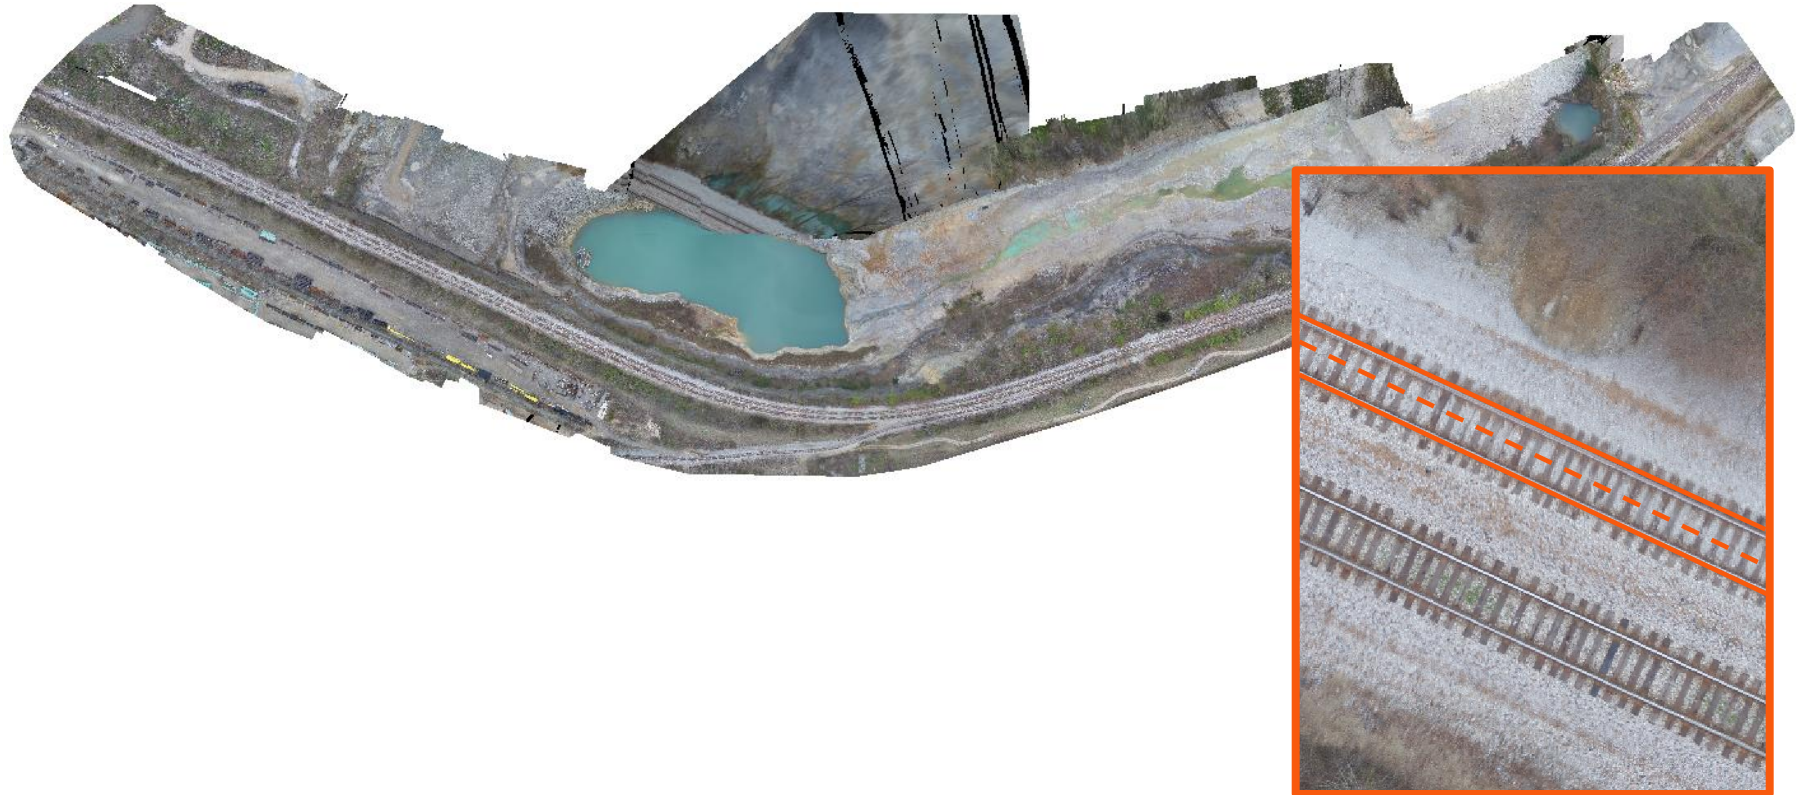
Alignment Profile Change Detection

Method creates line graphs of track section for monitoring through the highly detailed top-down stitched image (Orthomosaic). Lines are created for each rail then track centerline is computed. The rail and centerline can be easily be compared though simple line graphs.

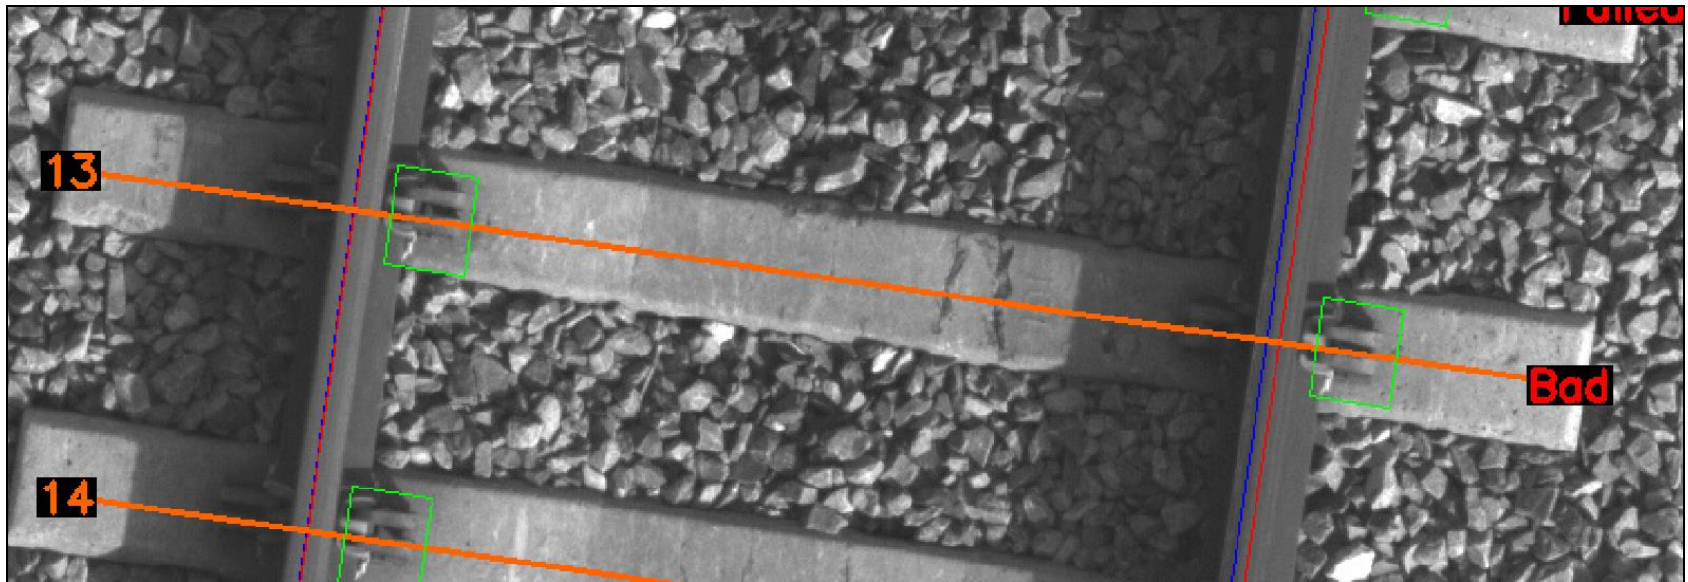
Concrete Tie Evaluation

- Tools for visualizing the data collection
 - Color indication of tie quality

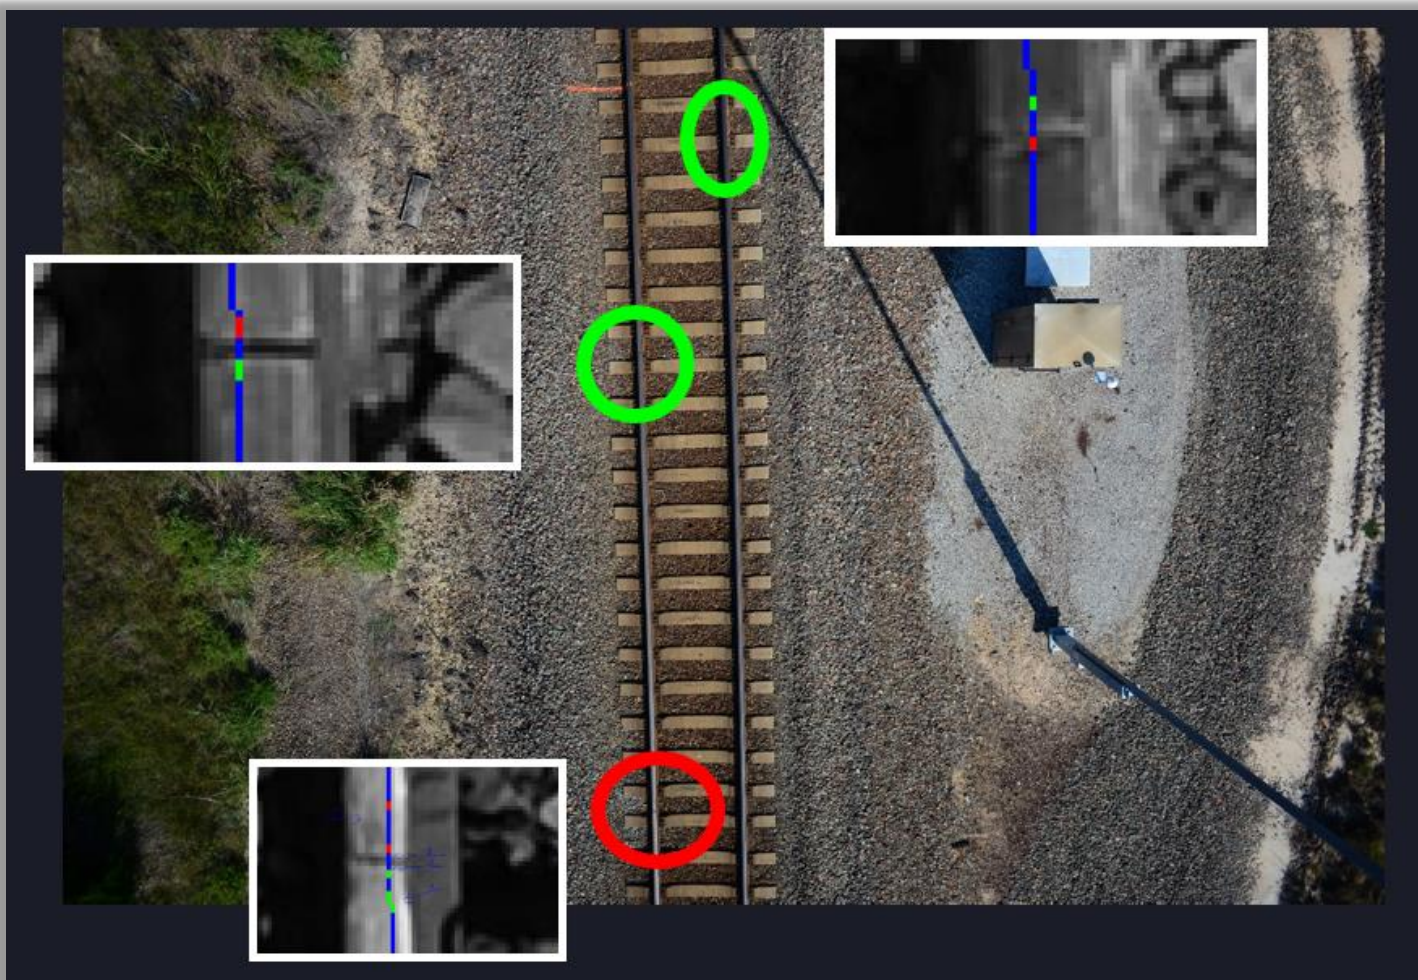
Actual break - Decatur

Rail Gap/break Detection Examples

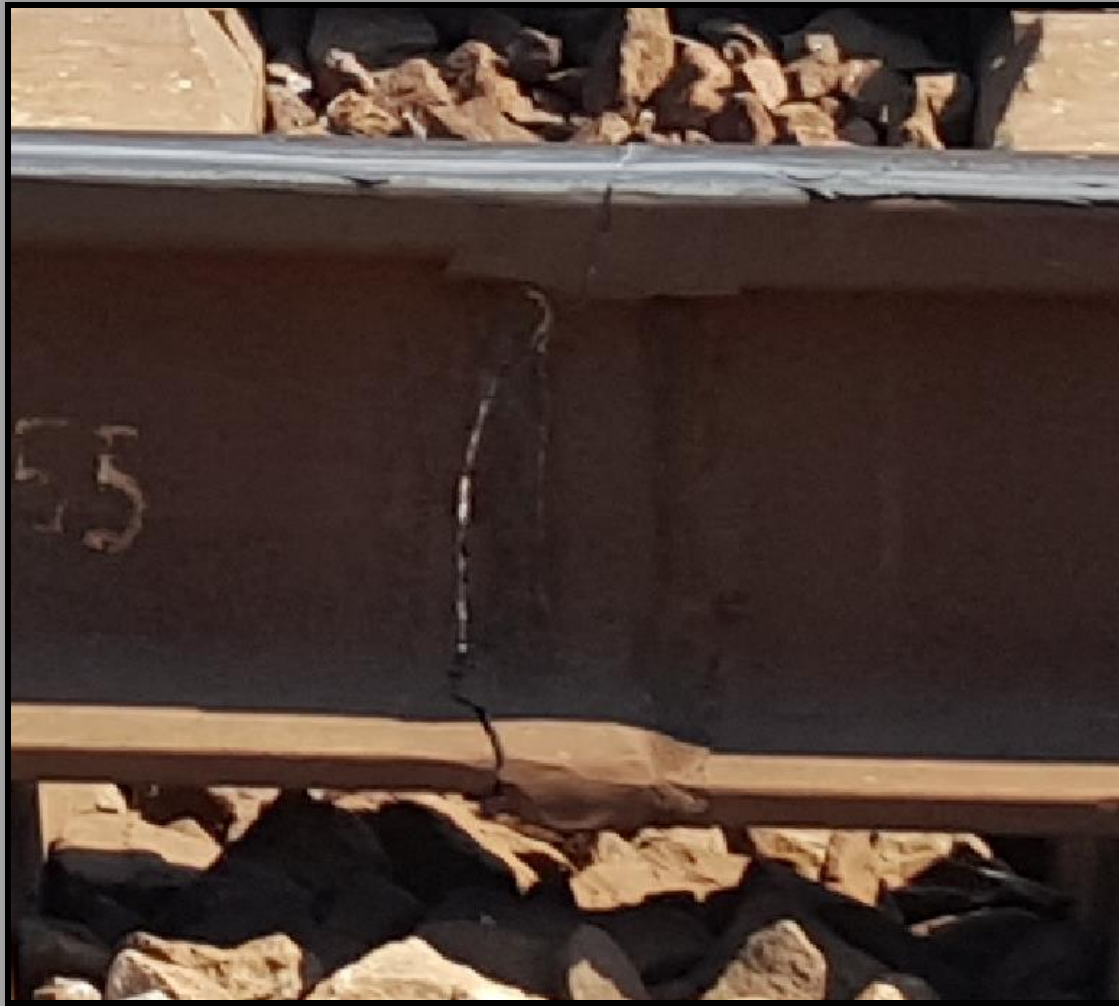
Actual break - Decatur

Rail Gap/break Detection Examples

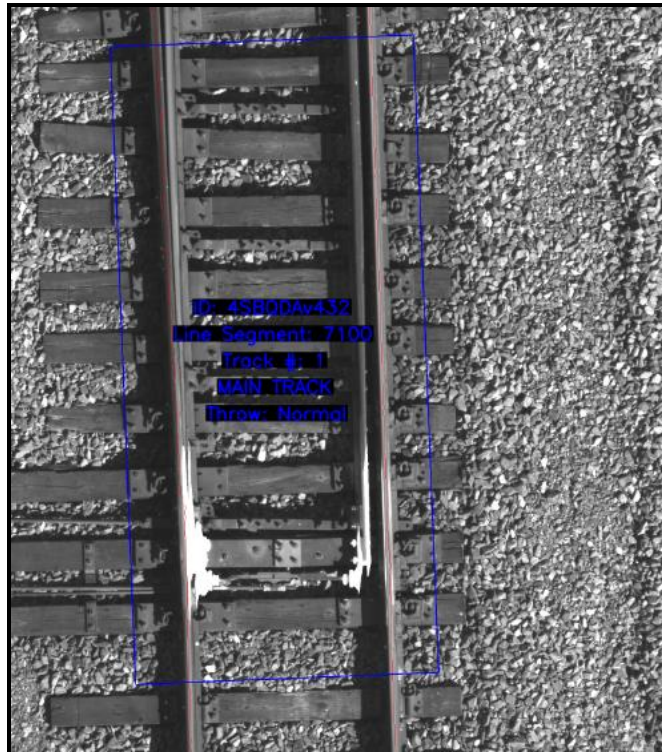
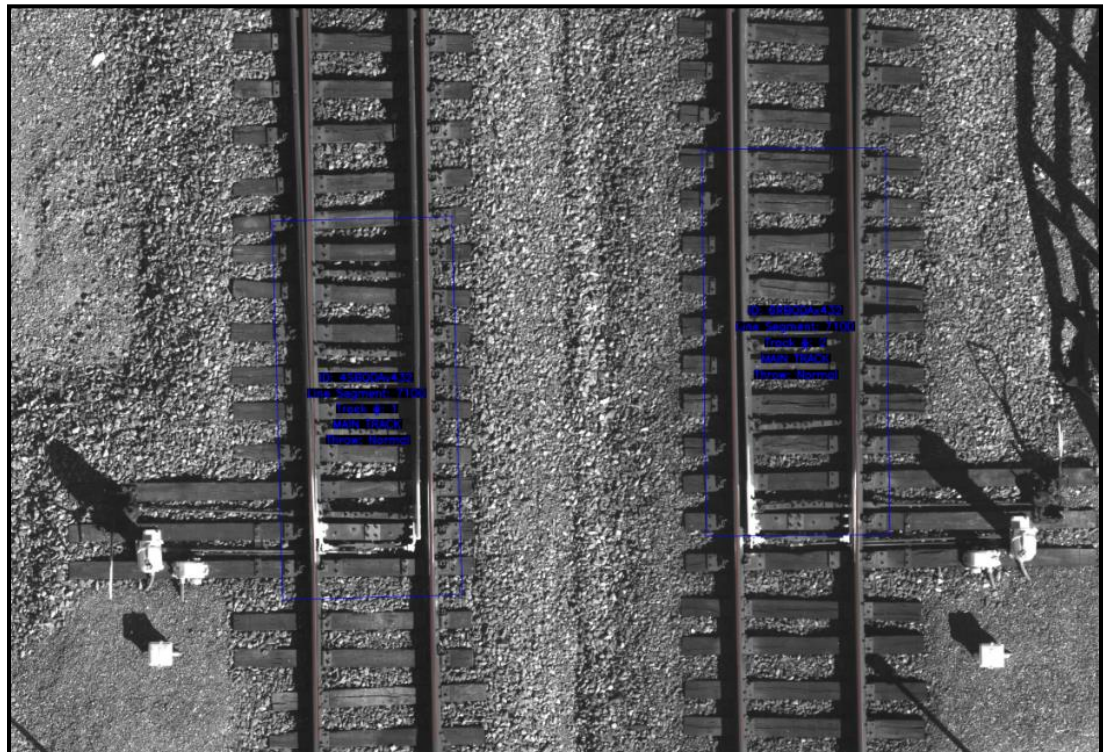
Switch Position Defection and Reporting

- Detection and evaluation methods implemented
- Turnout ID, Track Association, Normal or Reverse Throw
