Transportation Technology Center, Inc., a subsidiary of the Association of American Railroads

What's New at TTCI?

Lisa A. Stabler
President

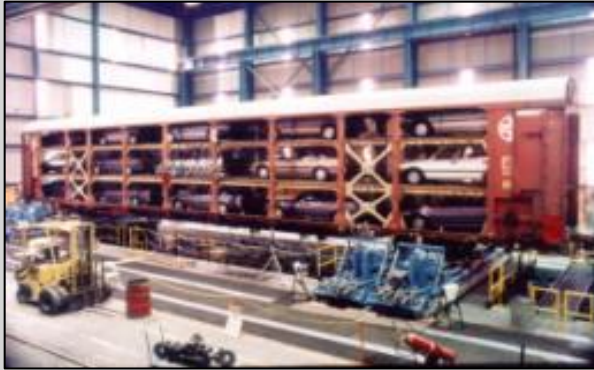
Vibration Test Unit

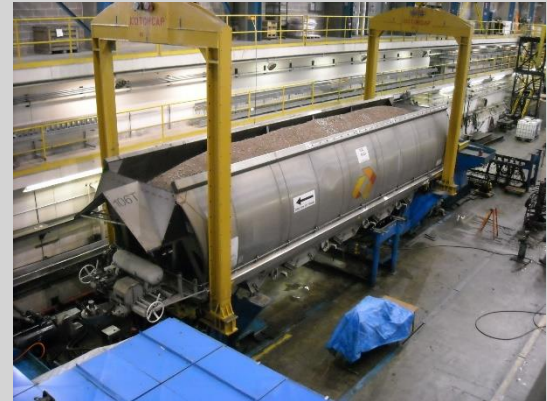
Simuloader

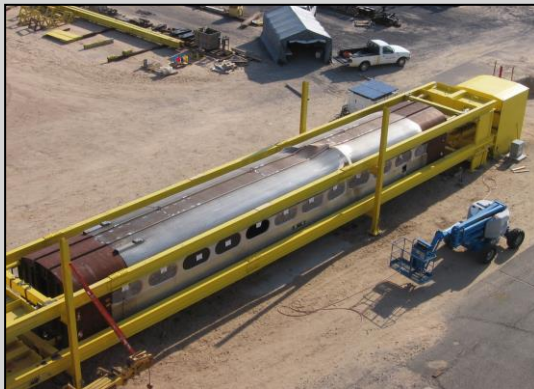
Squeeze Fixture

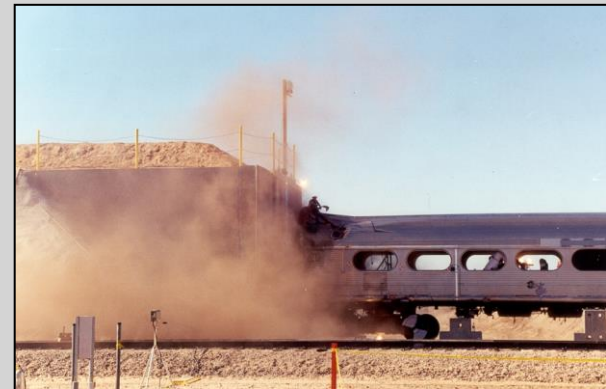
Impact Wall

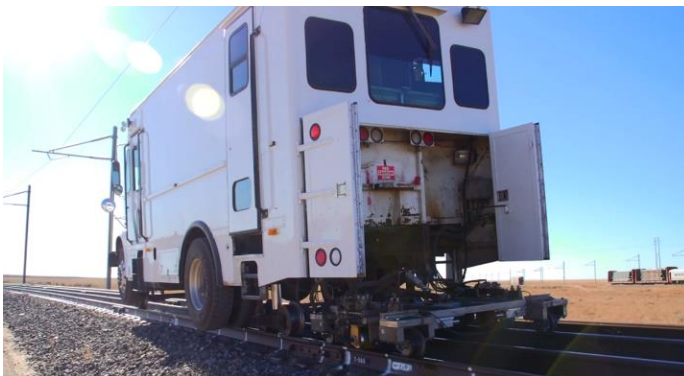
TTCI Phased Array Configuration

- ◆ Full Matrix Phased Array
- ◆ Optimized Probe Layout
 - Optimal railhead coverage
 - 20-mph vehicle inspection speed
 - Rail wear compensation algorithm
- ◆ Two Modes
 - 20-mph scan for flaws
 - High resolution mode
 - ▲ On-board flaw validation

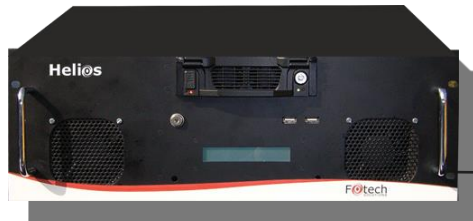
Fiber Optic Acoustic Detection

The system consists of two major parts:

- standard fiber positioned (e.g., buried) near the object to be analyzed
- the analyzer connected to one end of the fiber

The fiber acts as a distributed acoustic sensor along its entire path. Backscattered light provides a measurement every 1 meter along the fiber. A single 20 km fiber optic cable acts as 20,000 individual sensors.

Each meter of fiber acts as an individual sensor allowing for monitoring of time and position as well as allowing for the determination of event characteristics.

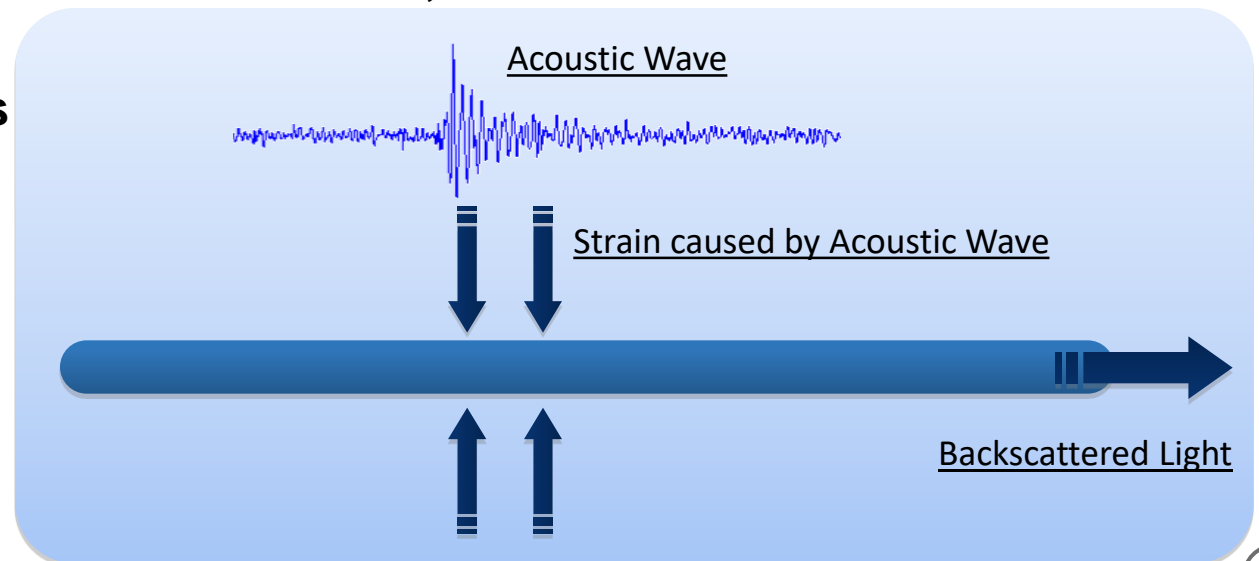
Fiber Installation on HTL

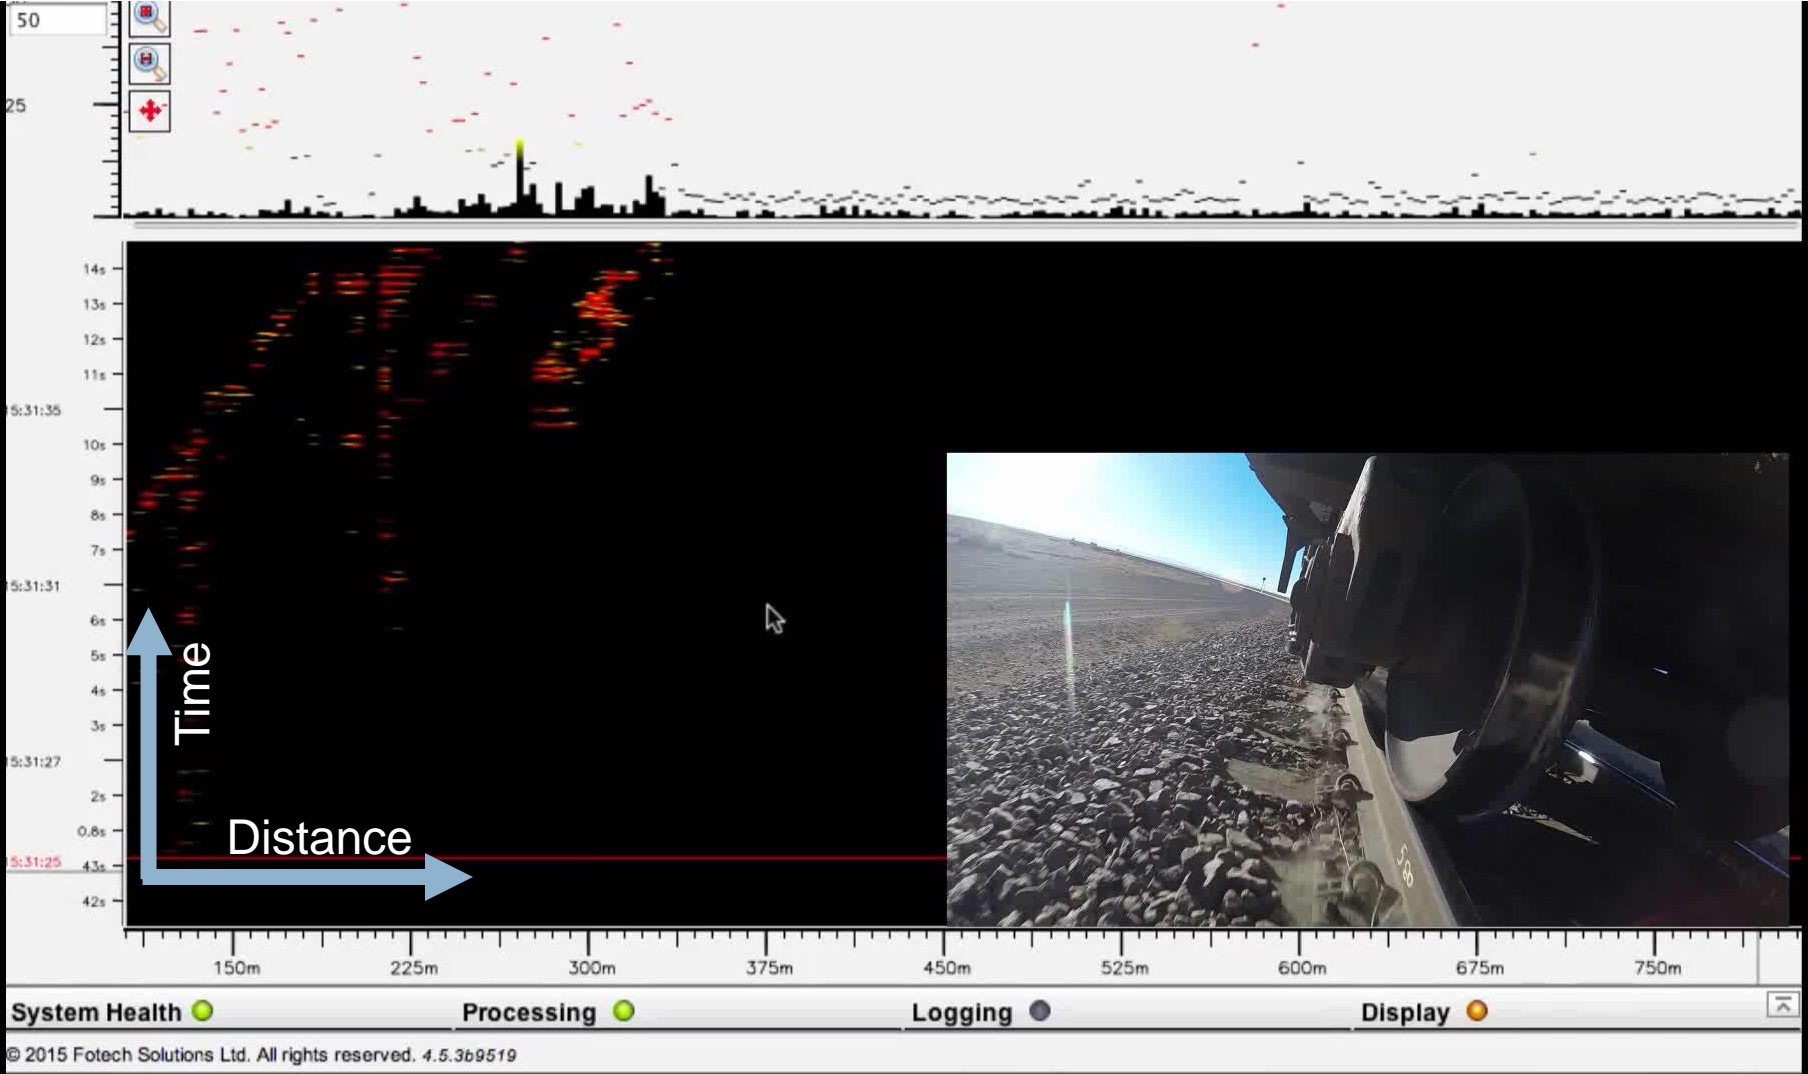
Example of Fiber Optic Signature from a Rail Break

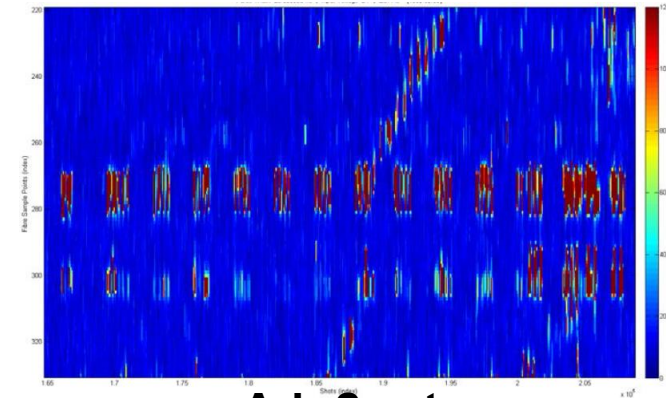
Axle Count

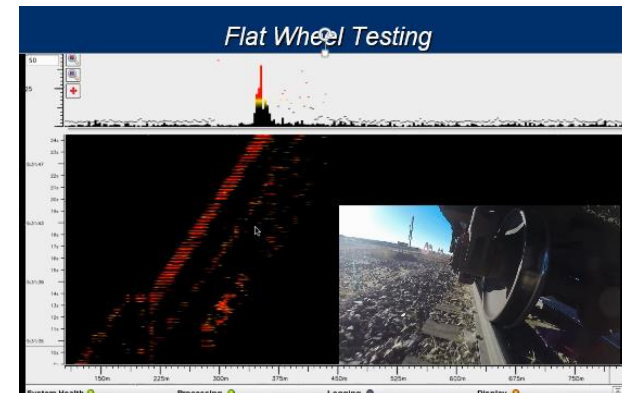
Flat Wheel

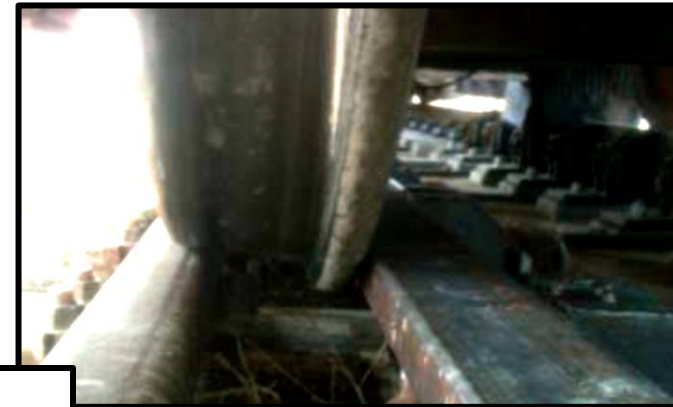
◆ Gauge-widen track

- 61.66 inch gauge as opposed to standard gauge of 56.5 inch.

◆ Wheels ride on edge of rim

- Exposes tread for UT probes

◆ Guardrails keep wheels centered

Schematic of gage widened track section

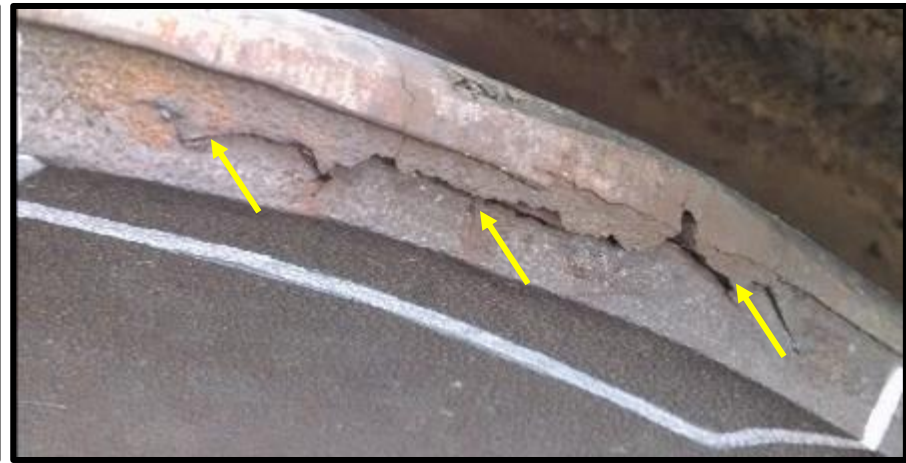
◆ SRC Wheel # 1: detected 100% at 15 mph

Wheel Defect Type	Handheld UT Measurement				
	Indications	Length [inch]	Width [inch]	Depth [inch]	
SRC Wheel 1	<ul style="list-style-type: none"> • Metal flow in shattered rim area (6" long x 2.9" wide) • Multiple sub-surface delaminations all around tread surface 	SRC			
		4.40	2.90	0.23~ 0.63	
		Sub-surface delaminations			
		0.60 ~ 1.60		0.22 ~ 0.26

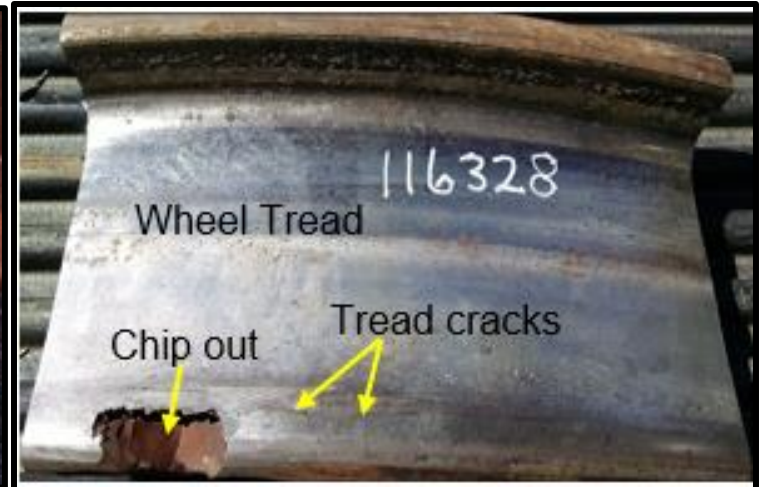
◆ SRC Wheel # 2: detected 7% at 15 mph

Wheel Defect Type	Handheld UT Measurement			
	Indications	Length [inch]	Width [inch]	Depth [inch]
SRC Wheel 2	<ul style="list-style-type: none"> • Visible crack and chipout in rim face • 3 Sub-surface delaminations • Visible shelling and RCF 	Chip out		
		1.00		1.00
		SRC		
		8.00	2.00	0.75
		Sub-surface delaminations		
		i. 0.50	i. 0.50	i. 0.20
ii. 0.25	ii. 0.25	iii. 0.21		
iii. 3.20	iii. 1.00	iii. 0.15

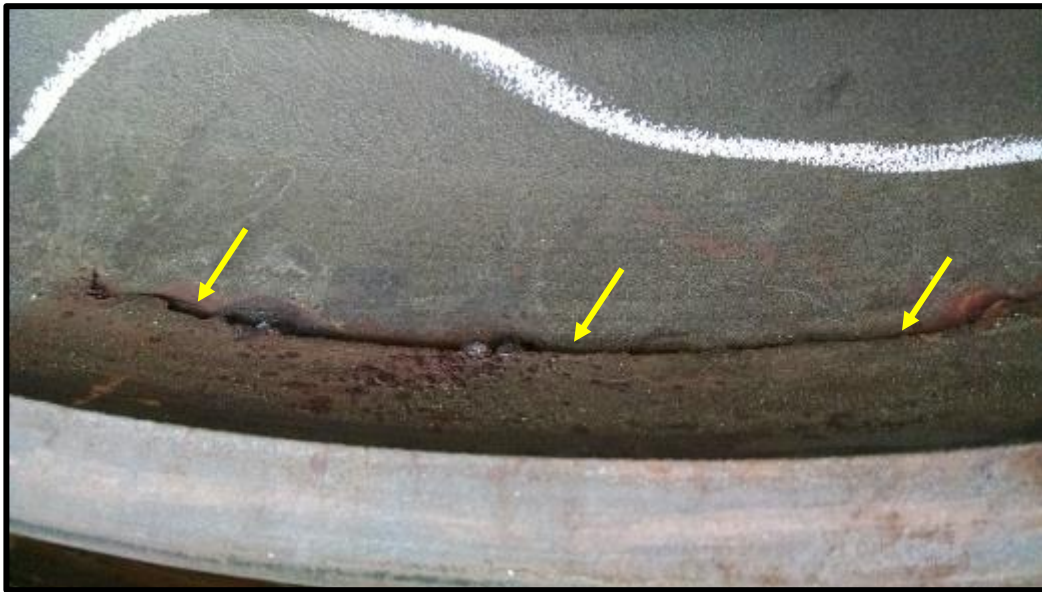
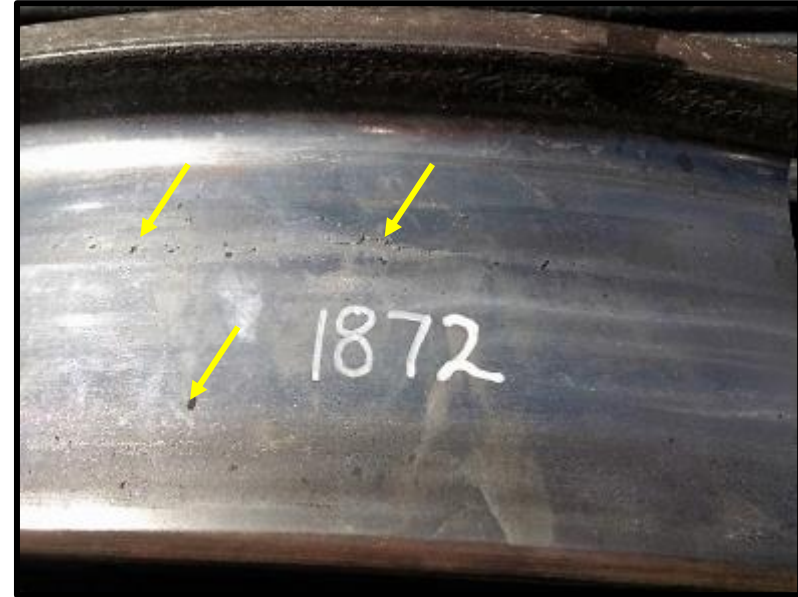
◆ VSR Wheel # 1: detected 73% at 15 mph

Wheel Defect Type	Handheld UT Measurement			
	Indications	Length [inch]	Width [inch]	Depth [inch]
VSR Wheel 1	<ul style="list-style-type: none"> • VSR crack in the field side fillet between rim and plate • Some RCF in tread 	9.00	2.00	1.00

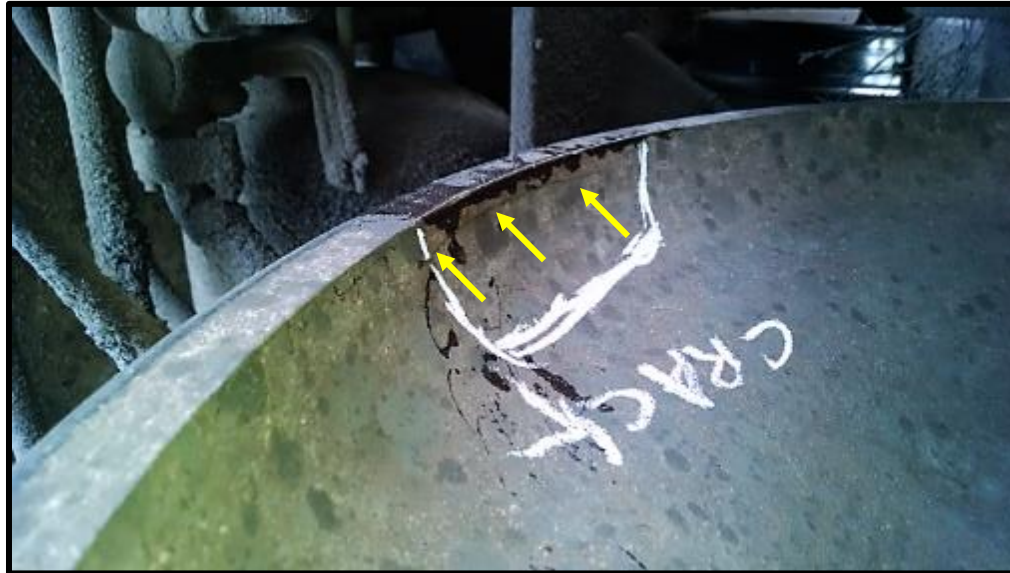
- ◆ VSR Wheel # 2: detected 100% at 15 mph

Wheel Defect Type	Handheld UT Measurement			
	Indications	Length [inch]	Width [inch]	Depth [inch]
VSR Wheel 2	• VSR crack in the field side fillet between rim and plate	6.00	1.10	1.04
