Industry Innovations Fleet Health Safety and Security

Rail Security Coordinator

Olin Corporation

GOAL:

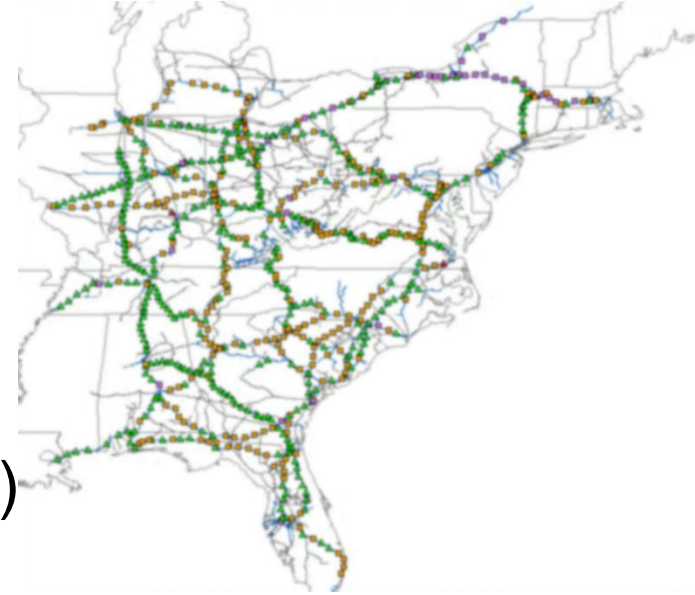
RailRoad Equipment Health

Class I RR – Wayside Sensor Network → ALERT Data → EHM

- THD- Truck Hunting Detector
- TPD- Truck Performance Detector
- WILD- Wheel Impact Load Detector
- ABD- Acoustical Bearing Detectors
- Others (Profilers, Hot/Cold Boxes, etc)

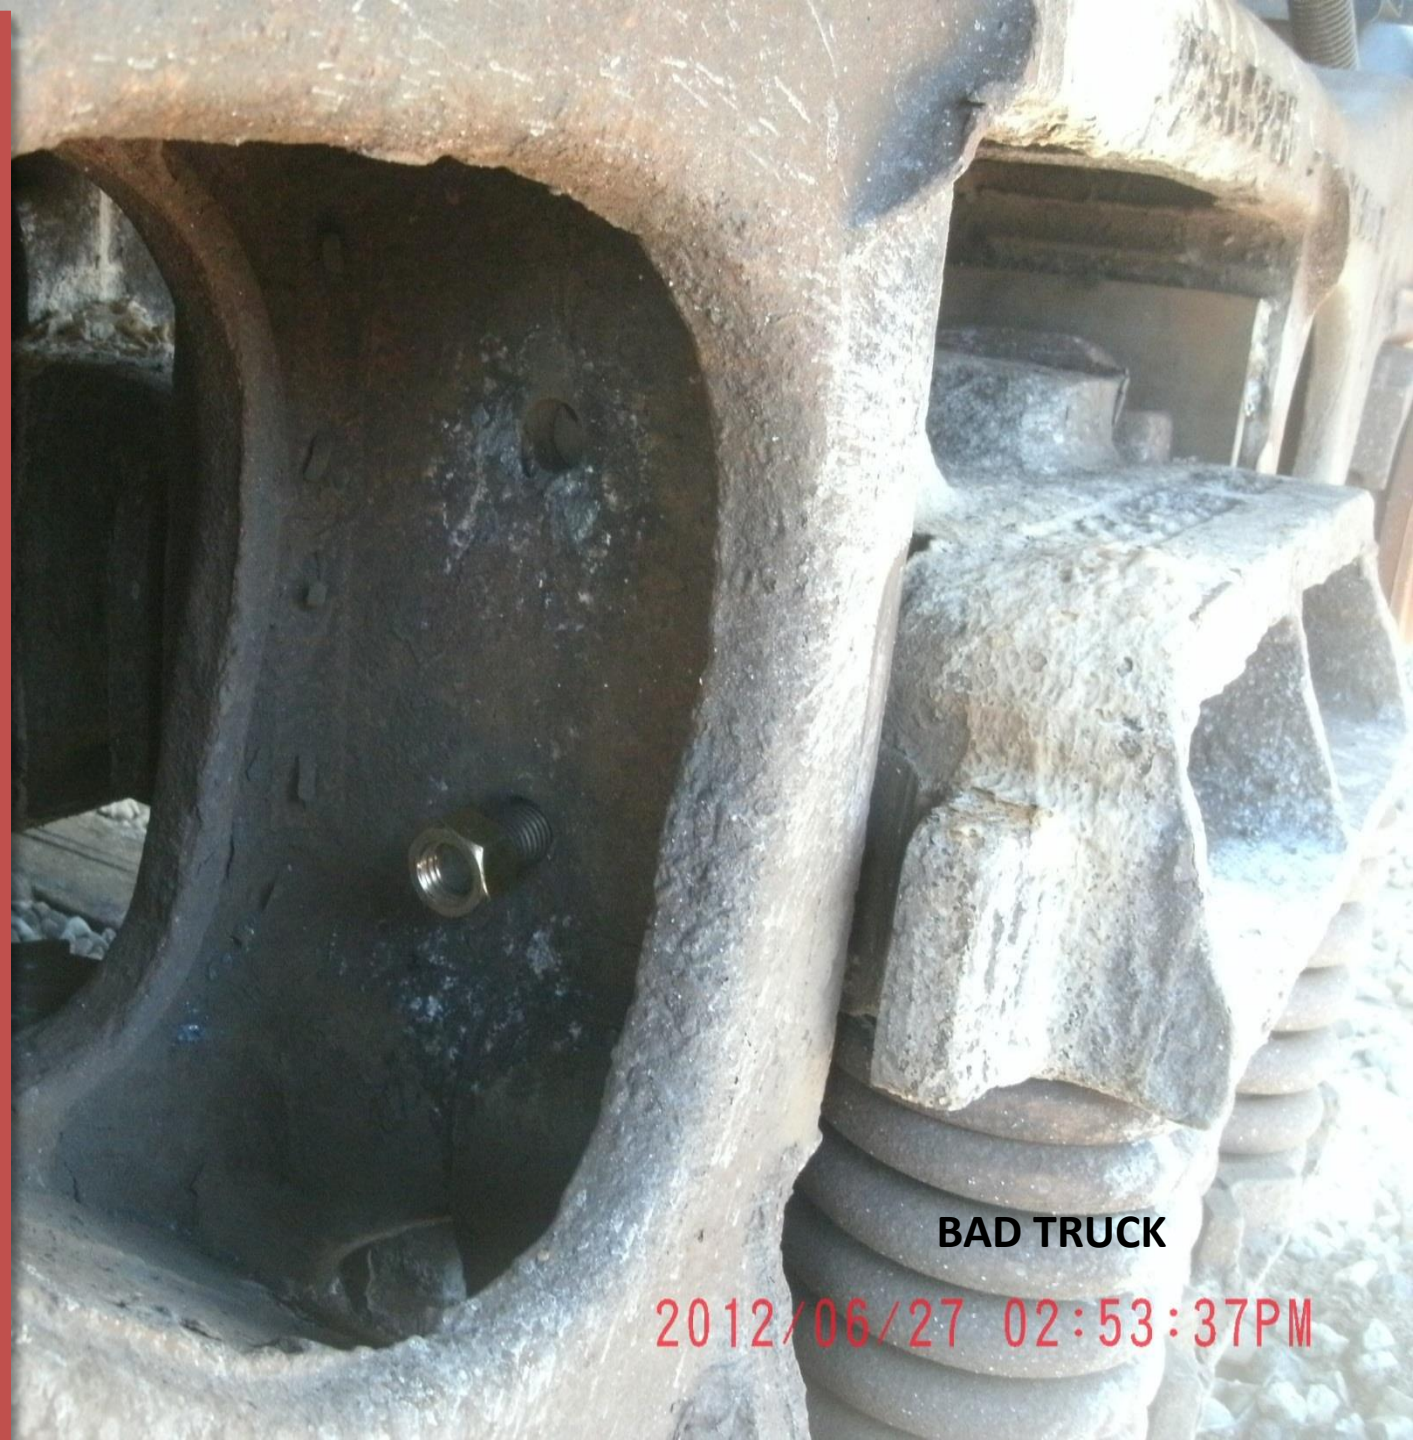
BAD TRUCK

2012/06/27 02:53:37PM

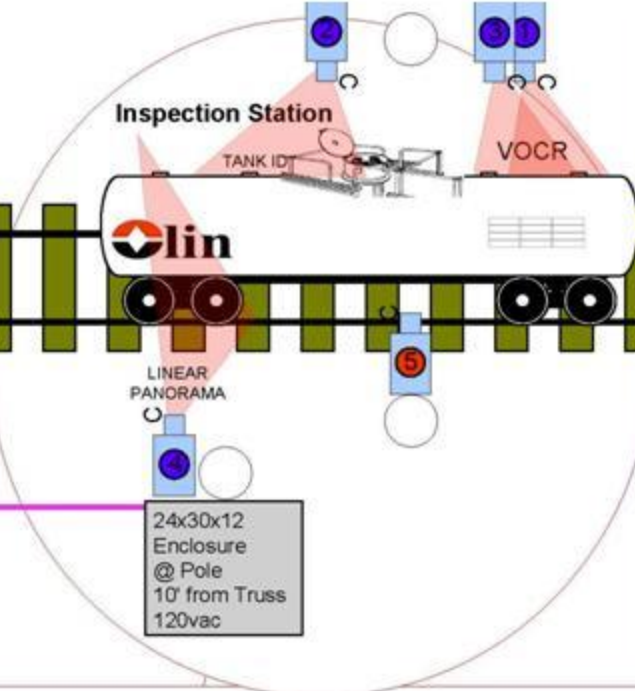
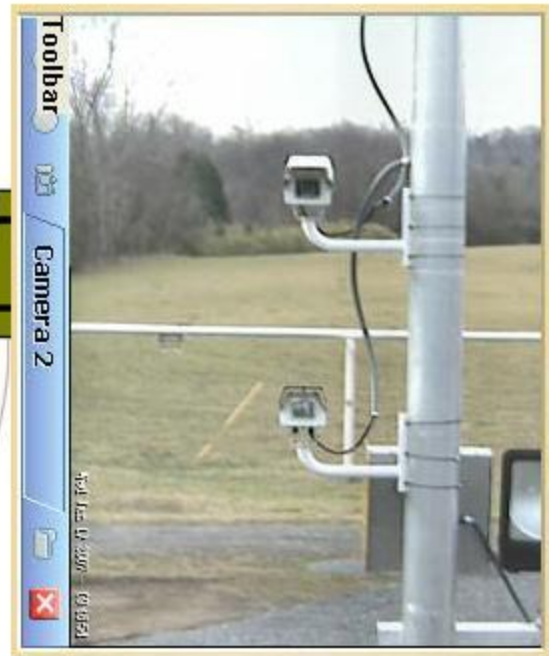
Entering / Leaving Plant

5 ~2.1mi.

Pelco Espirit PTZ Cam 5

Pelco 1390 Fixed Cam 4

Sony Ipela Fixed Cam 3

Sony Ipela Fixed Cam 2

Sony Ipela Fixed Cam 1

24x30x12 Enclosure @ Pole 10' from Truss 120vac

LINEAR PANORAMA

4" Conduit

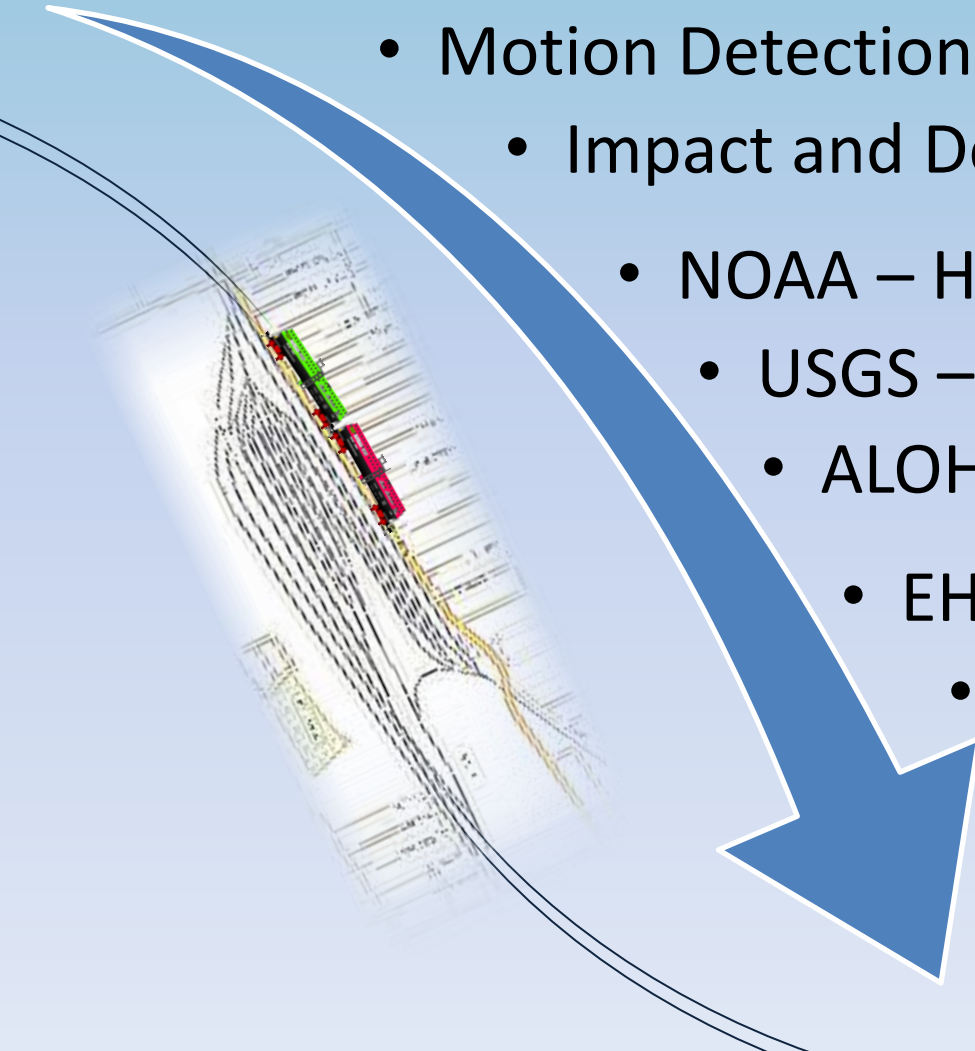
In-Transit Monitoring

- GPS with Open/Close Dome Detection
 - Motion Detection Image Capture
 - Impact and Deceleration Data
 - NOAA – Hurricanes Storms
 - USGS – Earthquake Data
 - ALOHA Plume Modeling
 - EHM Alert Data
 - CLM Data
- GPS**
- WEB**
- RailInc**

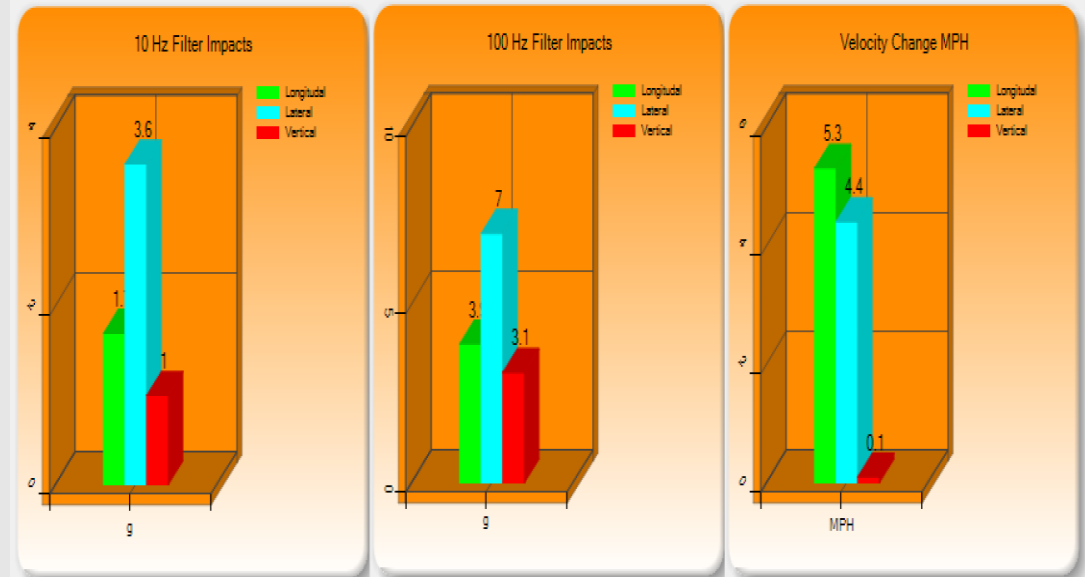
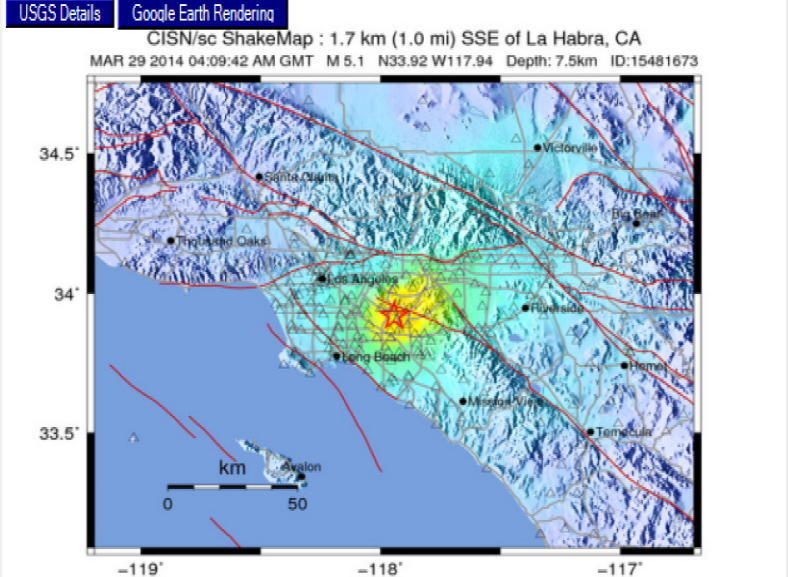
Impact Event Detail on PROX082402 for event 146222510

Quake Shake Map

car_number	z_10hz	y_10hz	x_10hz	z_100hz	y_100hz	x_100hz	z_dvmp	y_dvmp	x_dvmp	speed	cours
PROX082402	1.7	1	3.6	3.9	3.1	7	5.3	0.1	4.4	5	88

PERCEIVED SHAKING	Not felt	Weak	Light	Moderate	Strong	Very strong	Severe	Violent	Extreme
POTENTIAL DAMAGE	none	none	none	Very light	Light	Moderate	Mod./Heavy	Heavy	Very Heavy
PEAK ACC.(%)	<0.1	0.5	2.4	6.7	13	24	44	83	>156
PEAK VEL.(cm/s)	<0.07	0.4	1.9	5.8	11	22	43	83	>160
INSTRUMENTAL INTENSITY	I	II-III	IV	V	VI	VII	VIII	IX	X+

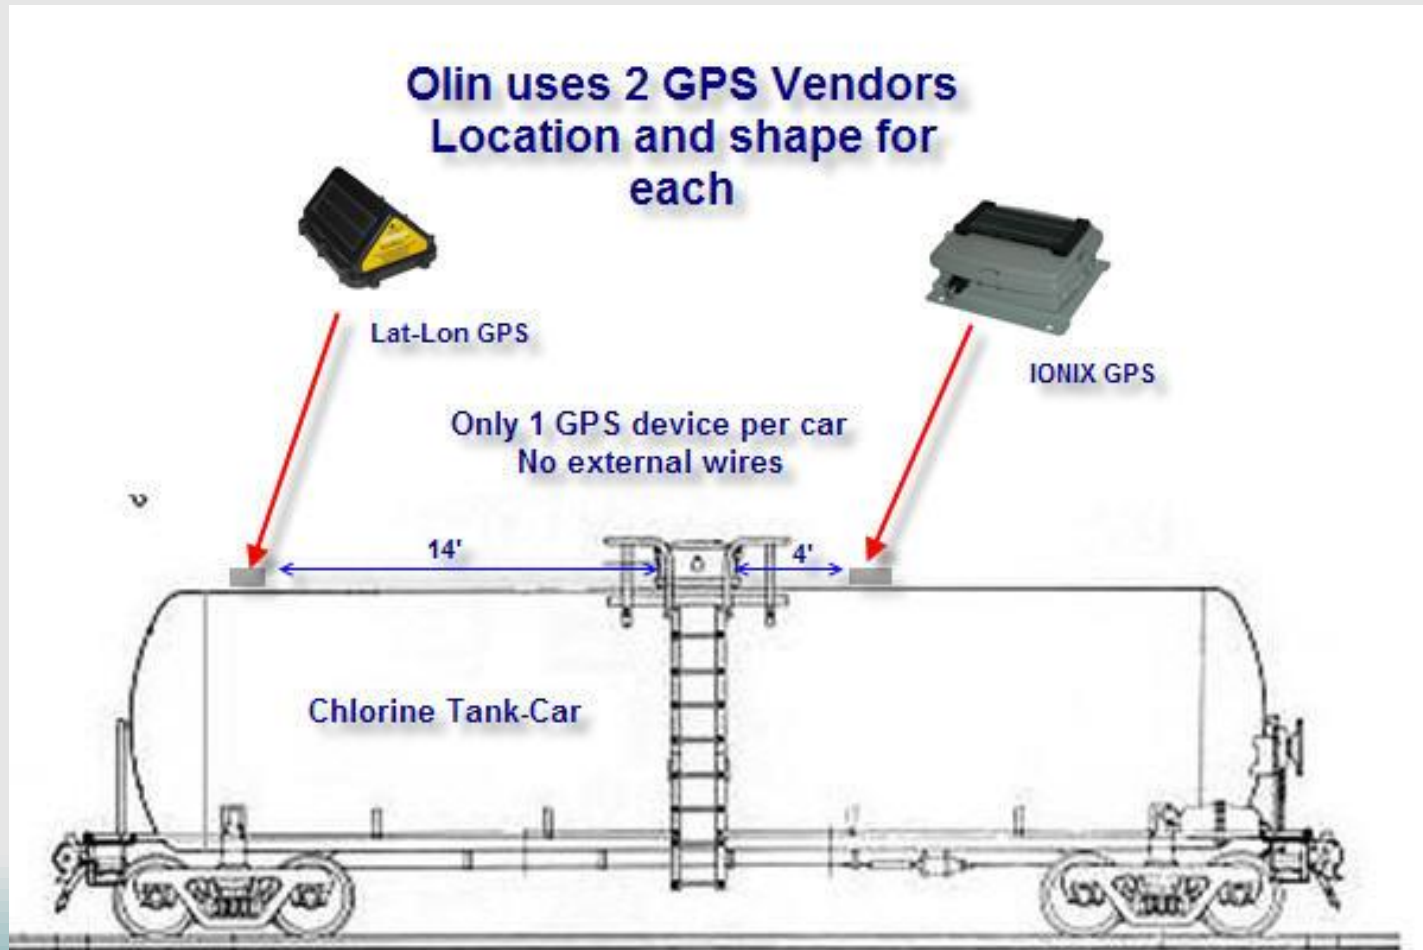
Multi-K Sensor Equipped GPS Devices

In-Transit Monitoring GPS

SECURITY (Tampering)

- Motion detection Image capture (pilot)
- In-transit valve dome access with Image

RIDE QUALITY

- Impact Accelerations in G's
- MPH Coupling and Decelerations speed
- Image Capture for high impact events

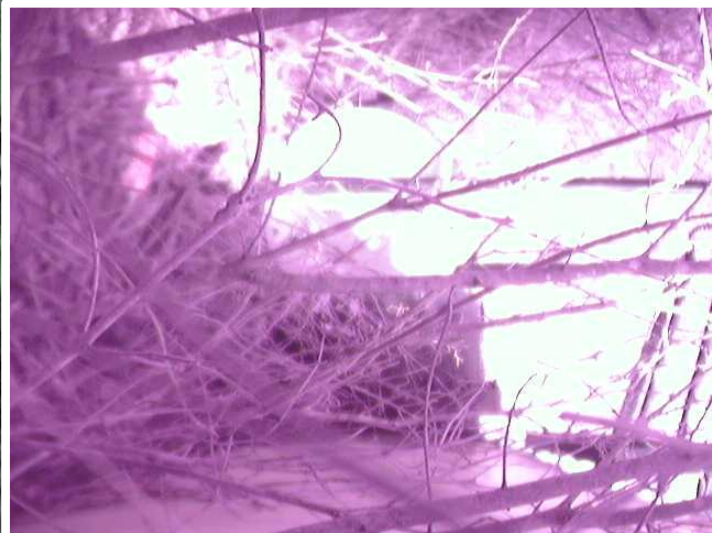
Derailment 9/17

SBLX014016 : 9/17/2012
3:10:32 PM
Loaded Moving Haynesville, LA .7G

9/17/2012 3:10:32 PM L 1 mph Going To BROMET, AR Impact Alarm Haynesville, LA .7G LNW R 00:00:00
[View Maint/Notes](#)

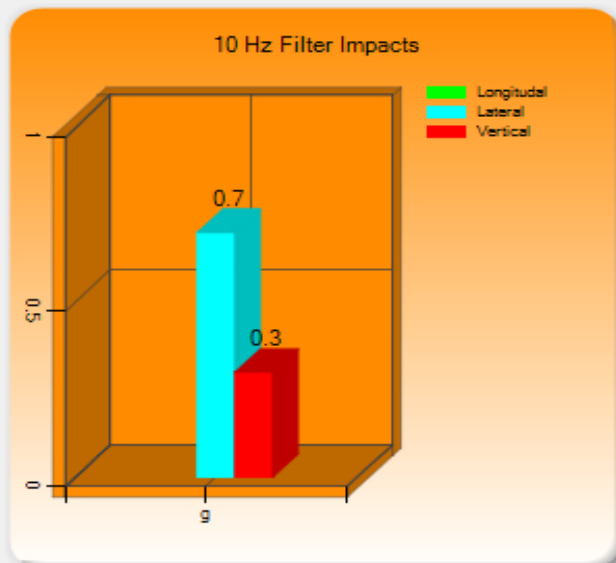
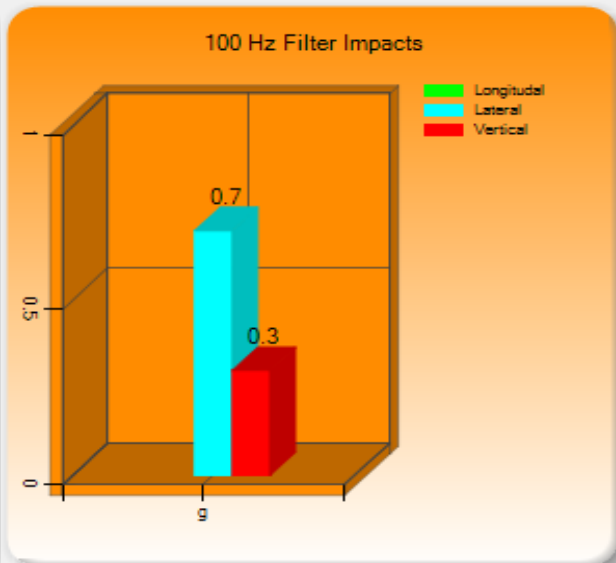
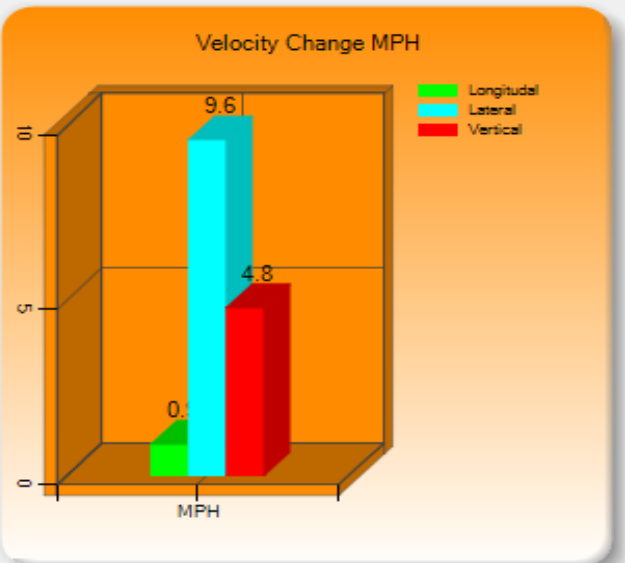
Impact Event Detail on SBLX014016 for event 95812723

SBLX014016										95812723		GO	Maintenance
vmph	y_dvmph	x_dvmph	speed	course	message_typ	photo	gps_unit	unit_id	id	unit_dttm	latitude		
	4.8	9.6	1	102	Impact Alarm	0	LAT-LON	233391161699	95812723	9/17/2012 3:1	32.898712

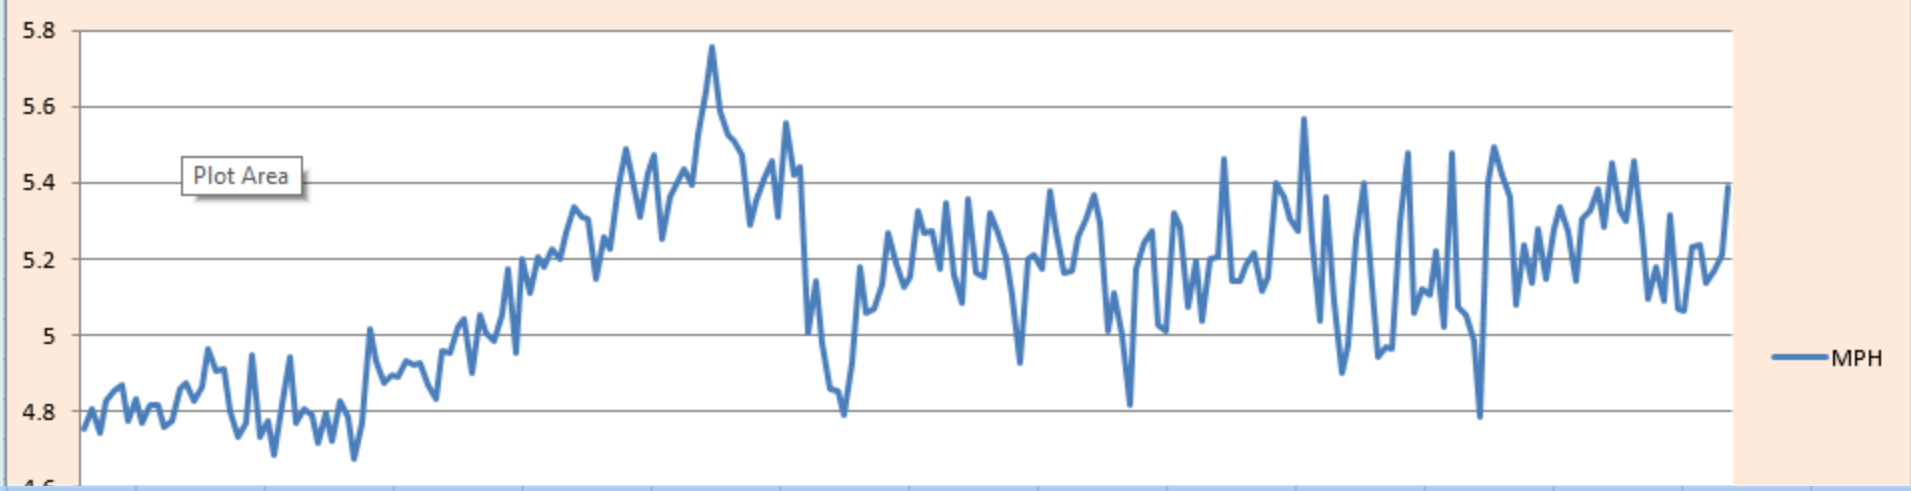
Weekly Deceleration Events 2011-2015

GPS Coupling Speeds (Decelerations)

- Speed checked in motion over 3 mph (GPS)
- Coupling Speed is reported as Speed-Drop
- Original Speed = Final Speed + Speed Drop
- Good Correlation between Delta-V from accelerometers and Speed Drop from GPS data

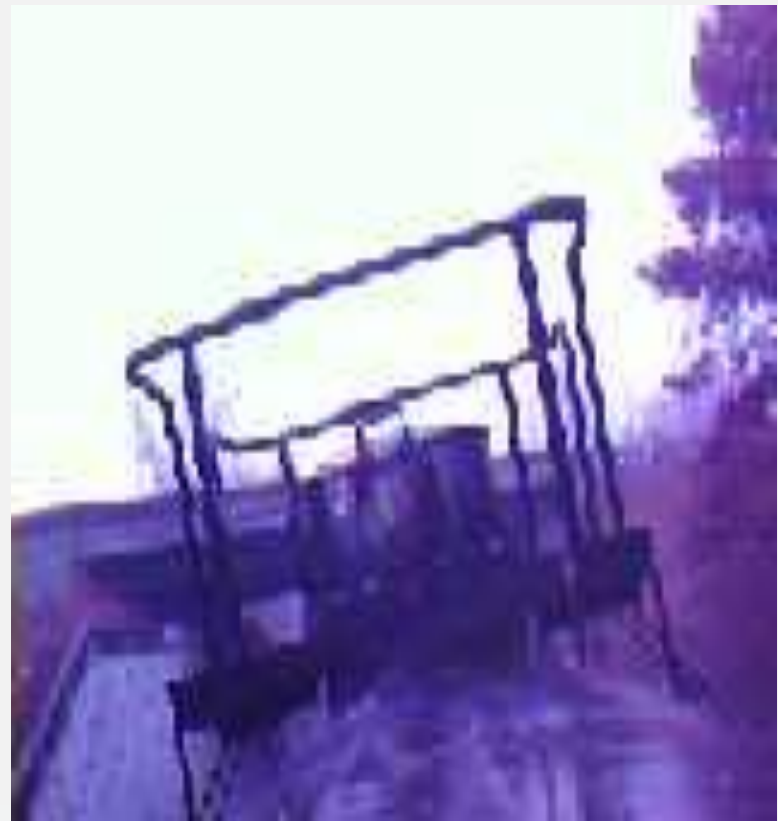
8 MPH with 4.9 G Lateral
